WEIGH-HOUSE

THE NEWSLETTER OF THE
SOMERSETSHIRE COAL CANAL SOCIETY

WEIGH - HOUSE N^o 47

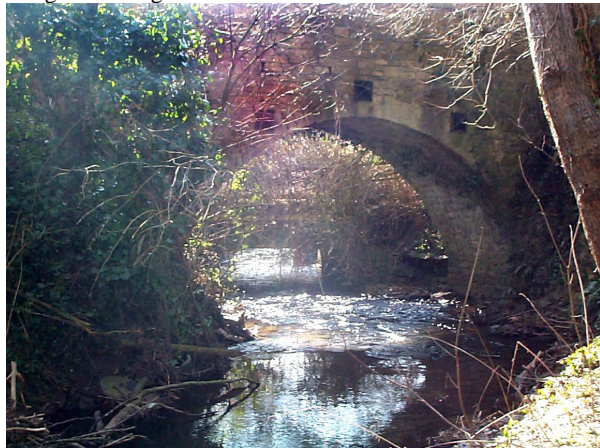
**THE WIDENED TRAMWAY BRIDGE
AT OLD WELTON PIT**

survives (although unsympathetically rebuilt in recent years), and the footings can still be seen of the bridge widening which was carried out to take an extra track when the GWR connection was made.

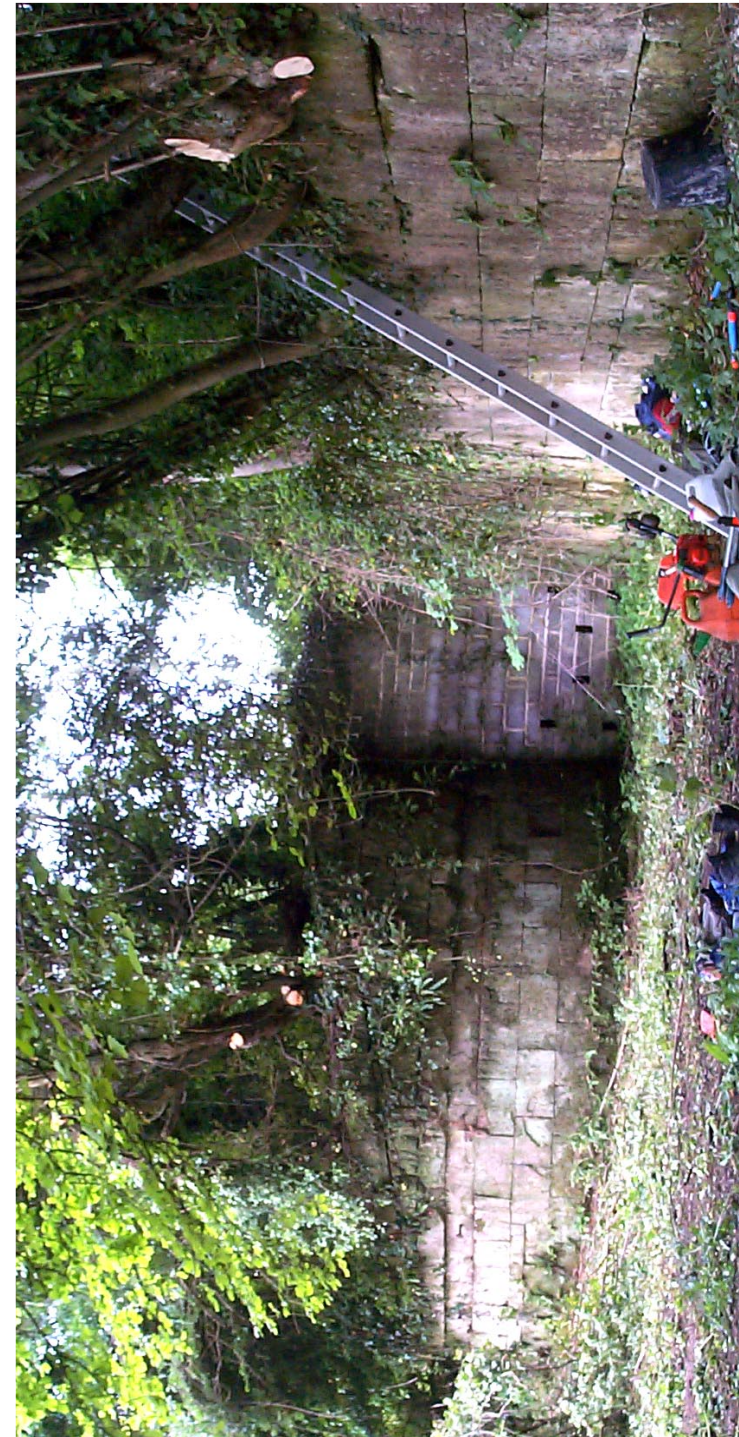
THE BASIN AT THE FORK IN THE CANAL BELOW LOCK 19

The lower reach which leads to the bottom of the Incline Plane is concealed in the bushes on the L.H.S. The rounded wall divides the lower reach from the entrance to Lock 19, which is currently walled-up at the point where it would have had a set of bottom gates. The wall on the R.H.S. appears to have been used as a wharf and there is a derelict structure (not visible) which may have been associated with loading boats at this point.

The fork, where the lower reach from the bottom of the inclined plane joined the canal just below Lock 19, has not been tackled by any of our work parties before. Recent inspection showed that, not only was it beginning to get a bit overgrown, which isn't much of a problem, but some of trees were beginning to work their roots into the stonework—which is a much more serious matter. The most recent work parties have been directed to that area and quite a lot of scrub and nettles was removed in a short while.

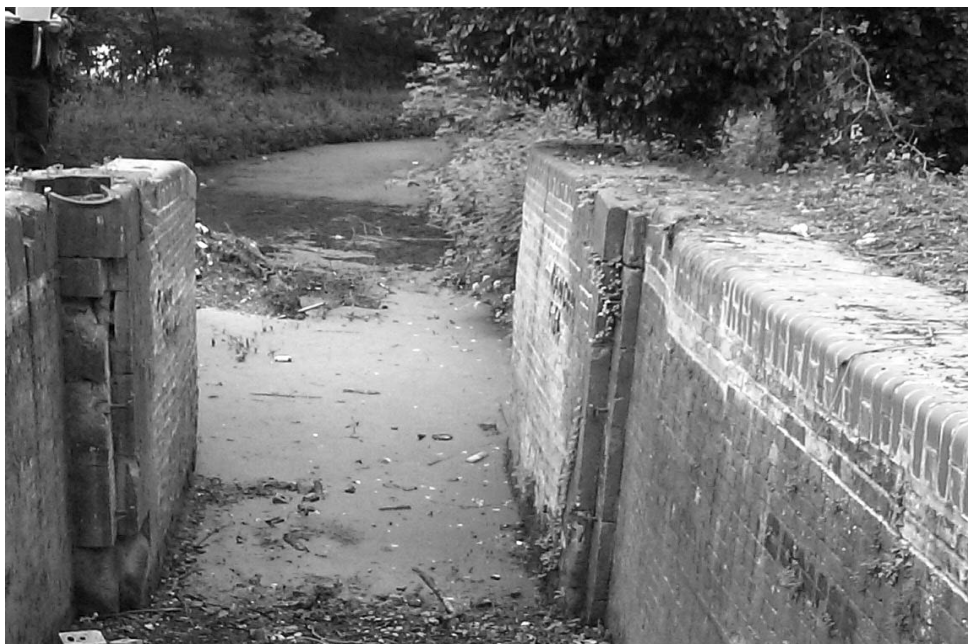
CALNE TOWN LOCK with the newly-restored canal beyond. Note the top hinge strap in place, ready to receive a new gate

West of the wharf the navigable part of the river ends and the canal itself begins at the town lock. Here, work by the Wilts & Berks Canal Trust has partially restored the lock, although a large water main which had been laid through the lock chamber, has still to be moved before full restoration can progress.

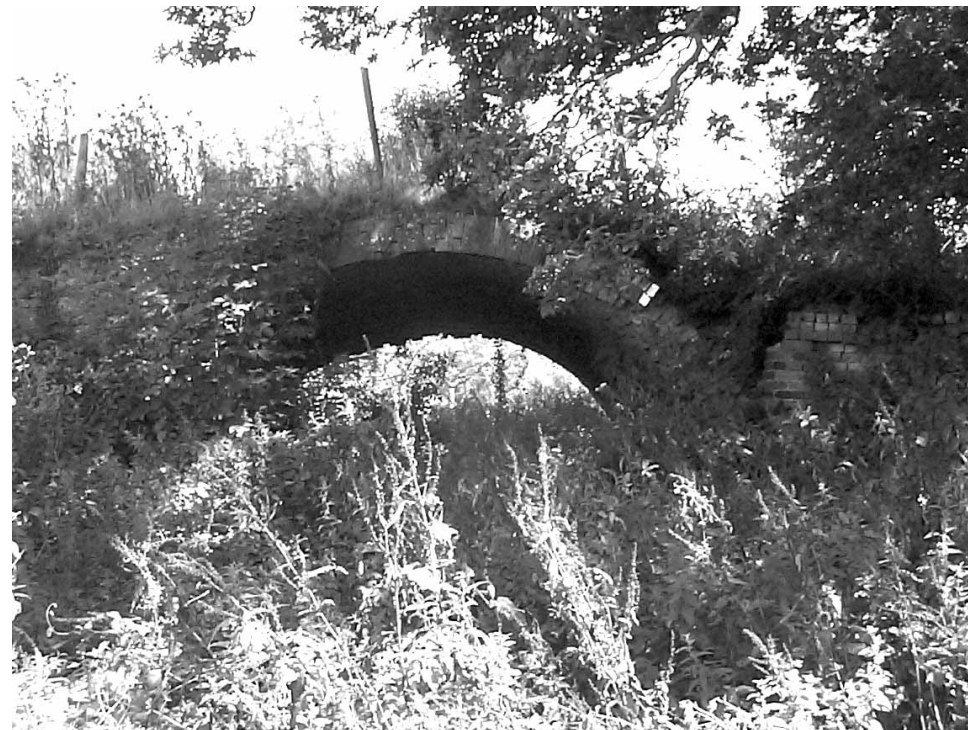
DOUBLE BRIDGE - As we saw it before it was rebuilt

Double Bridge

Called "double bridge" because it is wider than a standard bridge, (although only 50% wider, not twice the width), this is one of the very few original arch bridges left on the canal. Nobody knows why it was built in this way; it doesn't appear to be on a major route, just a small track down to the river Avon. There is no sign of an historic crossing of the Avon anywhere near here, so we can't understand the rationale. The bridge was in a very sorry state at the time of our visit, but recently it was completely rebuilt by a team of volunteers.

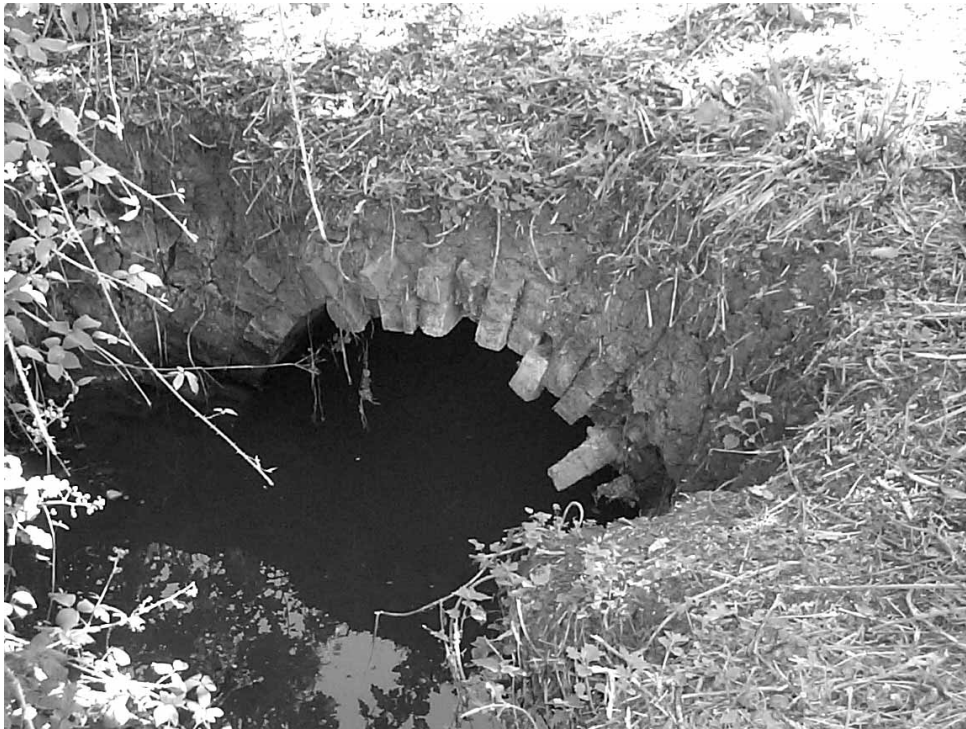
ONE END OF THE COLLAPSED CULVERT

Collapsed Culvert

A brook passes under the canal through a culvert which has collapsed, giving rise to a large hole in the canal bed. The intention is to construct a new culvert parallel to the existing one, then decommission the collapsed culvert, possibly digging it out and salvaging the bricks.

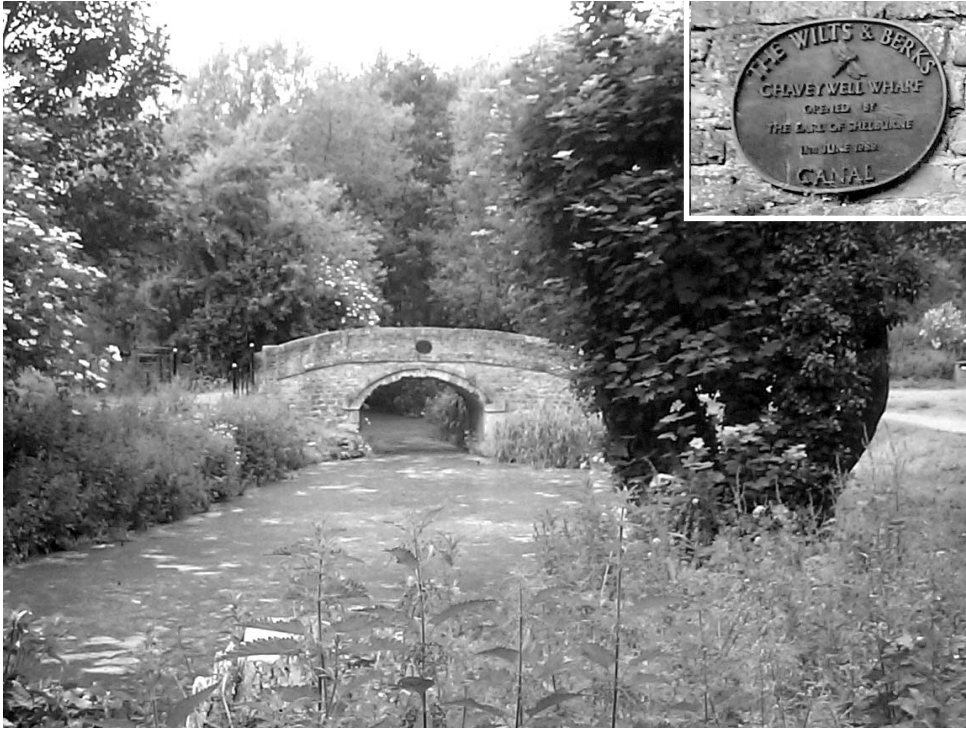
CHAVEYWELL BRIDGE ON THE WILTS & BERKS CANAL AT CALNE

Further along we came to a completed piece of restoration, Chaveywell Bridge, a fine brick-built accommodation bridge, and a few yards further on was a winding hole for boats travelling to and from the wharf. This section of canal is in water and is very popular with both walkers and fishermen, although on the Sunday we walked it, the large amount of weed growth on the water seemed to have deterred the even hardiest of fishermen from attempting to try for a catch.

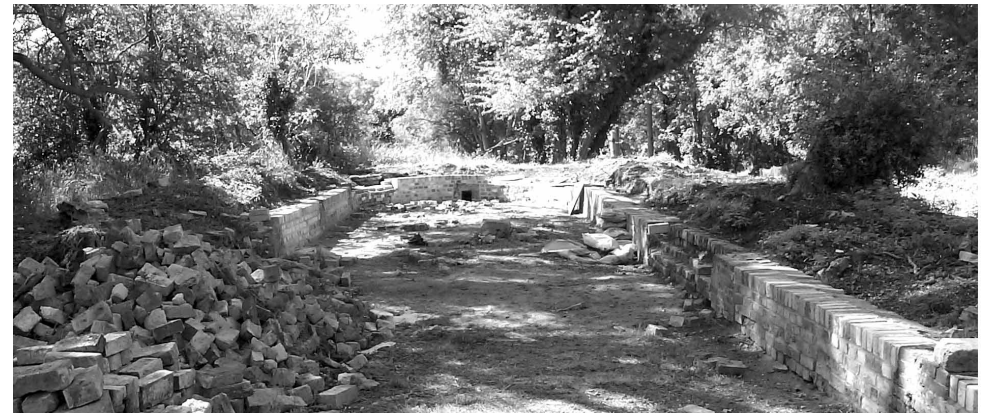
THE DRY DOCK in the process of rebuilding

placed when the hull was being worked on. The drain from the dock to the bottom pound has been uncovered; however, in its present condition it appears to be liable to cause problems from erosion, so perhaps a stone lining, which would have prevented this, has been robbed from the outfall.

Dry Dock

Located adjacent to the Middle Lock, this structure has given rise to a number of unanswered questions. It is about 14 feet wide, which would allow room to work around a 7ft-wide hull. However, the base of the dock gives the impression that it is too high to allow a boat to float in; but I'll bet it isn't! This may give us some indication of how little draught was required by a completely stripped-out horse drawn boat. During excavation a large quantity of broken slate was discovered, indicating that the structure once possessed a slate roof. Deposits of tar on the brick invert form a continuous strip, showing where the boat was

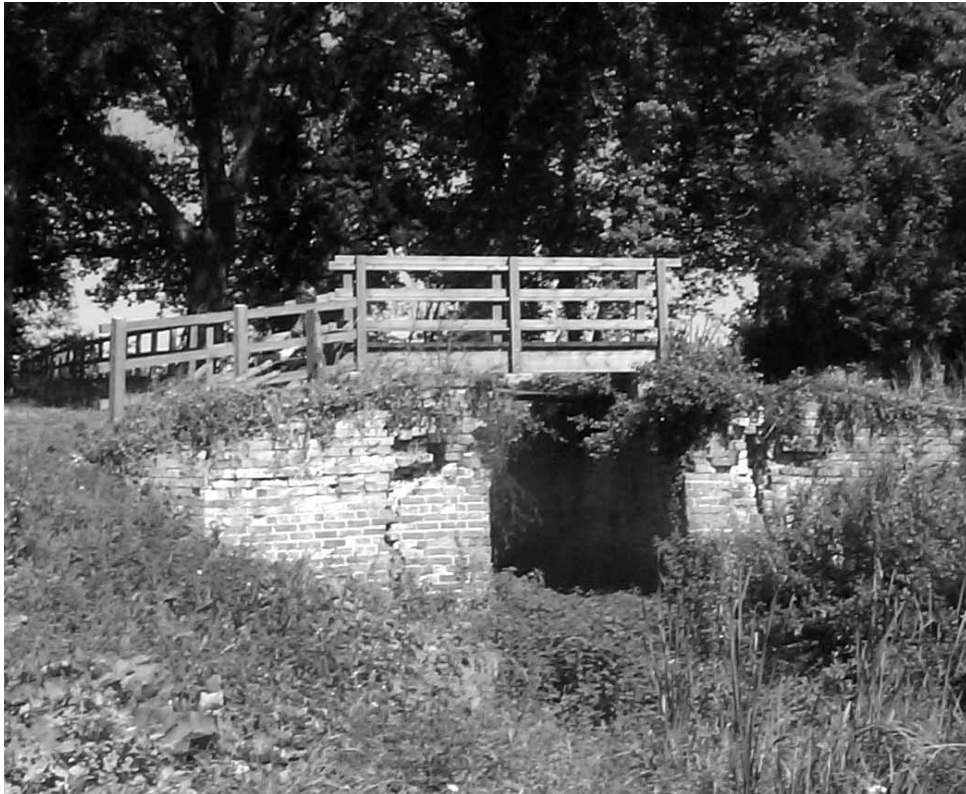
TOP LOCK OF THE PEWSHAM FLIGHT
A modern bridge over the bottom end

Top Lock

The top end of this lock has been badly damaged at some time since the closure of the canal, local lore suggests that the worst of this damage occurred when Canadian troops used it for demolition practice during the Second World War. Happily the bottom end is in much better condition and a nice pair of gate recesses still survives, surmounted by a small modern timber bridge to maintain a right of way. The springing of the original brick arched bridge can still be seen. This lock demonstrates a common feature of locks on the western end of the Wilts and Berks, one gate recess is large enough to accommodate a single bottom gate whilst the other is only large enough for one of a pair of a double bottom gates. This suggests that that the canal was originally built with single bottom gates then converted to double gates at a later date.
