# WEIGH-HOUSE

THE MAGAZINE OF THE  
SOMERSETSHIRE COAL CANAL SOCIETY

**WEIGH - HOUSE N<sup>o</sup> 49**

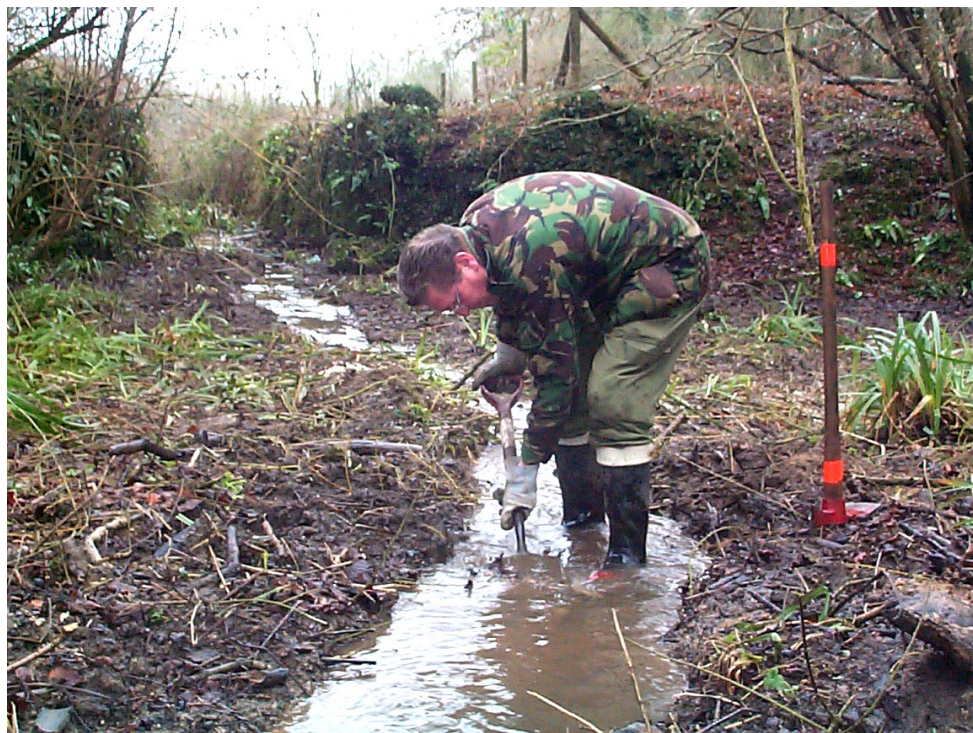
**WORK AT THE BULL'S NOSE — January 2008**  
**Bob Parnell attempting to re-open the canal single-handedly?**

*Once again our work parties have returned to the locks above Lock 16; this time the work site was at the northernmost point of the lock flight, the “Bull’s Nose”. We had been told by the landowner that a tree had fallen and was in danger of damaging the canal structure, but this didn’t really prepare us for what we found when we got there.*

The base of the tree had been firmly rooted in a wall on the inside of the Bull’s Nose bend and had done a fairly thorough demolition job on the stonework - firstly during its lifetime and then, more spectacularly, during its demise. The roots, however, were not giving up, so despite the tree having fallen several months before our work party arrived, the branches had continued to be well supplied with water, making them difficult to cut and even more difficult to burn.

We have now spent three work parties chopping up and attempting to burn this one tree, but there is still enough work, and wet wood, left to keep at least one more work party busy.

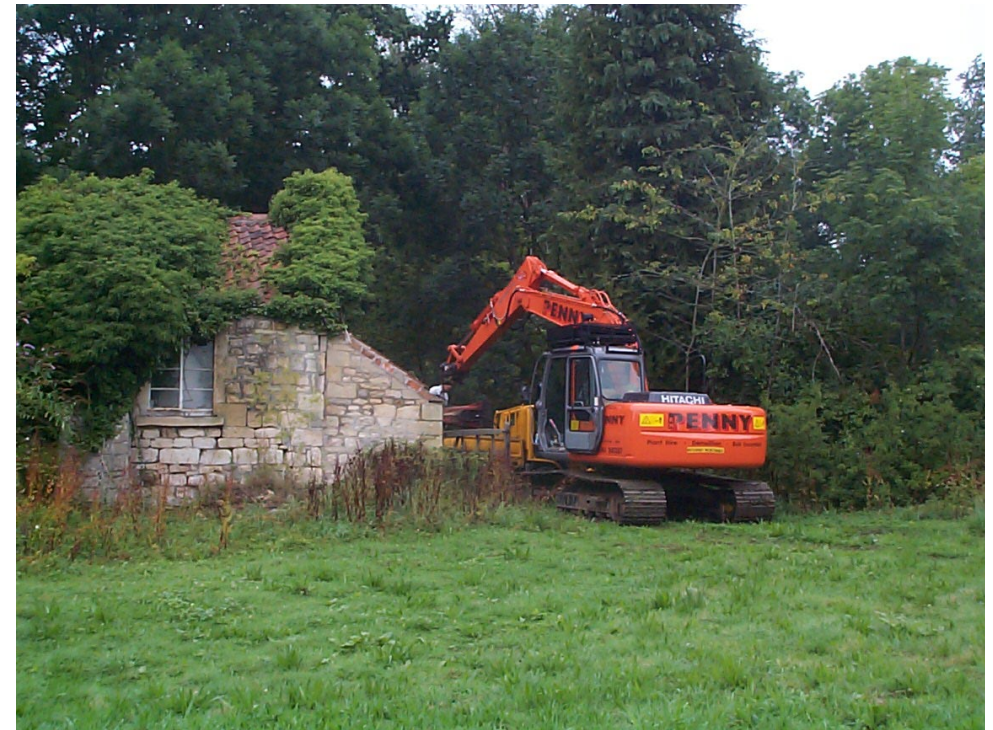
**THE CORNER OF THE WORKSHOPS — August 2003**

The excavator was entering Caisson Field for an exploratory dig and it is standing roughly where the entrance to the caisson might have been situated.

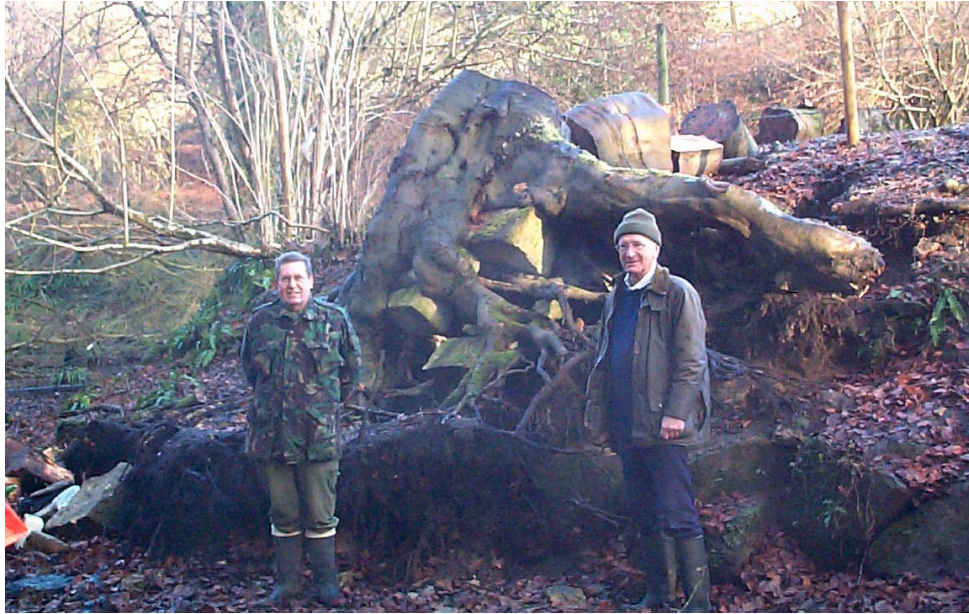
**THE STUMP AND ROOTS OF THE FALLEN BEECH TREE AT THE BULL’S NOSE  
with Bob Parnell and Harold Philips**

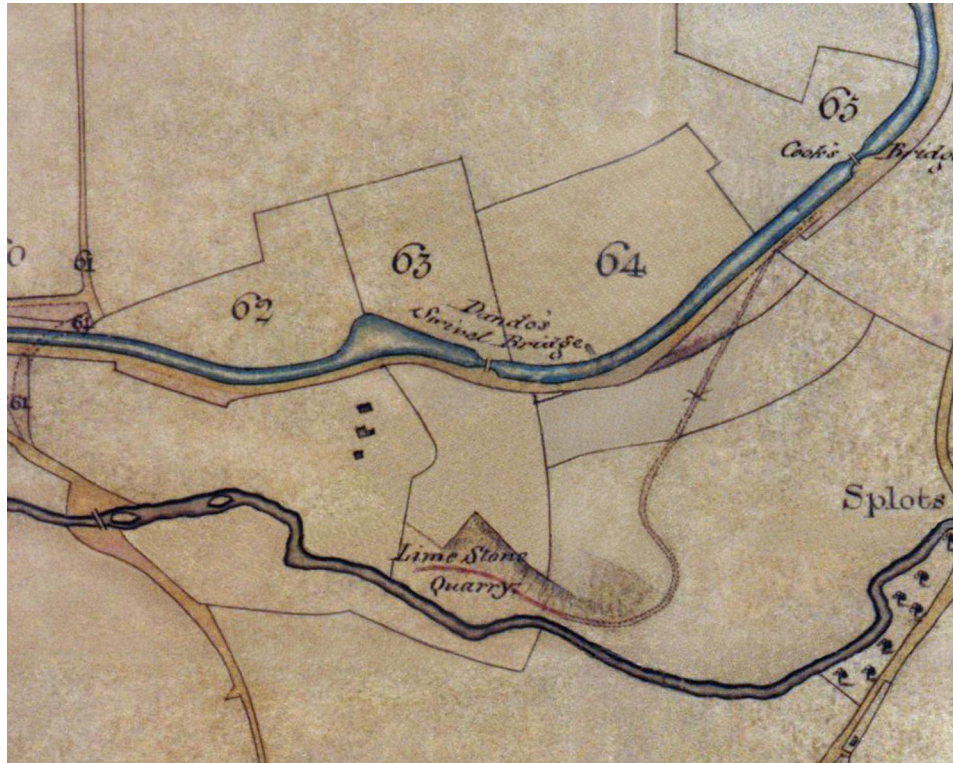
**THE QUARRY ON THE SITE OF DUNKERTON COLLIERY**  
As shown on the Cruse Map c.1810, between Stoneage Lane (left), Splott Bridge (right),  
and the Cam Brook (bottom)

The tramway, which had way-leave through several neighbouring grounds to a wharf beside "Cook's" accommodation bridge, may not have lasted very long. On the Cruse map it has been crossed out in pencil, and all that is indicated on the site on the 1840 parish tithe map is a lime-kiln where the stone was evidently being burnt with coal supplied from the nearby Camerton Pits. The 1884 OS first edition large-scale map shows the situation in more detail. The lime-kiln and quarry (the latter by this time much extended into the neighbouring grounds) are still present, but also shown, in the separate

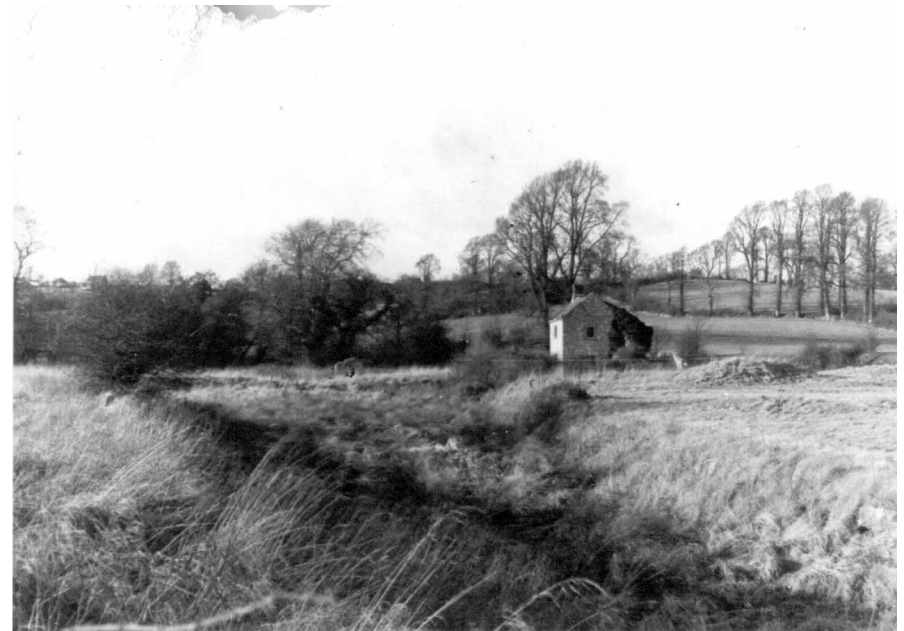
Photograph: Ron Gilson

**A View of the Paulton and Timsbury Basin showing the Cottage**

The canal terminated in a basin near Timsbury (657577) which can still be clearly seen, and from which a number of tramroads radiated †.

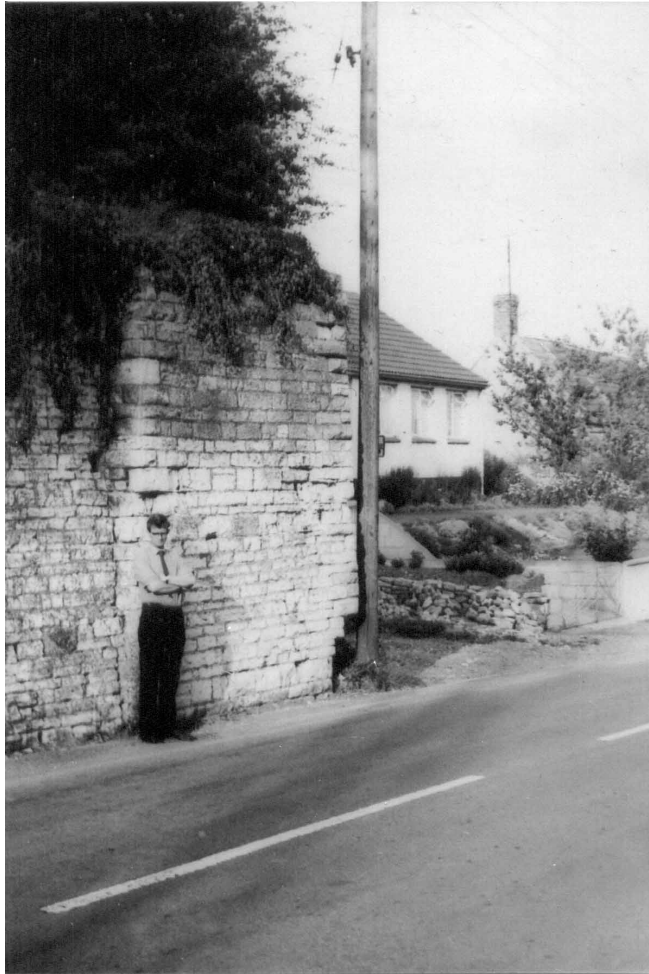
Abutment of bridge that carried the tramway from Welton Hill Colliery to the GWR in 1960s.  
Since demolished

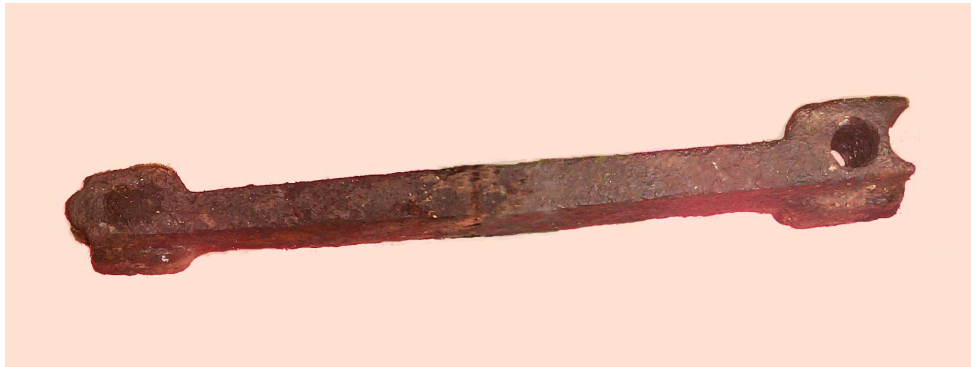
A RAIL FOUND NEAR DUNKERTON COLLIERY

The discovery of a tramway rail here would not in itself be unexpected. The colliery made much use of tub-railways to dispose of spoil, etc., and it has also been pointed out that the adjoining brickworks behind Splott Farm did much the same. However, by strange coincidence, the rail was recognised to be of the type seen at Conkwell Quarry during a Society walk there in October 2006, as reported in the last issue of *Weigh-House* (No.48). Since this type belongs to the early 19th century, the possibility arises that this rail is a fragment of the original quarry railway shown on the Cruse map. Unfortunately, it does not lie *in situ*, and it could be argued that it was somehow thrown over the fence of the scrapyard and had come from elsewhere, perhaps Timsbury and Paulton where these rails are said also to have been used.

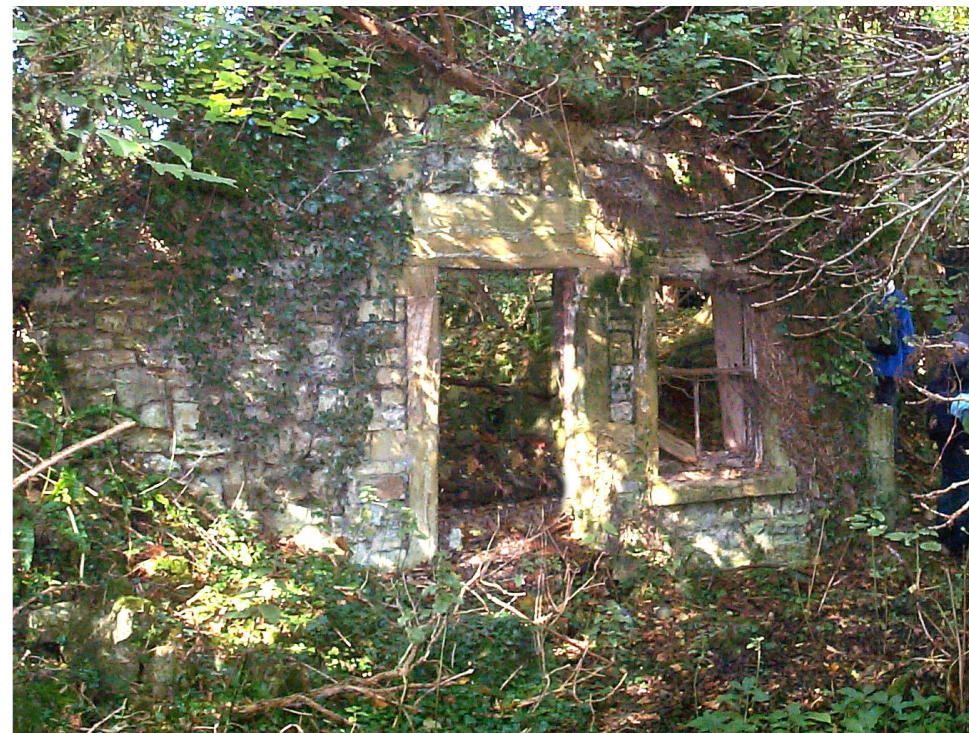
**PART OF THE EXTENSIVE RUINS OF  
"THE BOATMAN'S" or "THE BARGE" PUBLIC HOUSE**

Nevertheless, there is still a possibility that it came from somewhere nearby, so the ruins and their surroundings continue to be of archaeological interest. The ownership of this strip of ground also remains unclear, being separate, it would seem, from the rest of the Colliery area. All that can be said for now is that it was once part of a large field (plot 64Æ on the Cruse map) on the north side of the canal, which later became the site of the railway sidings and is now returned to farm-land. In short, further research will be needed here.

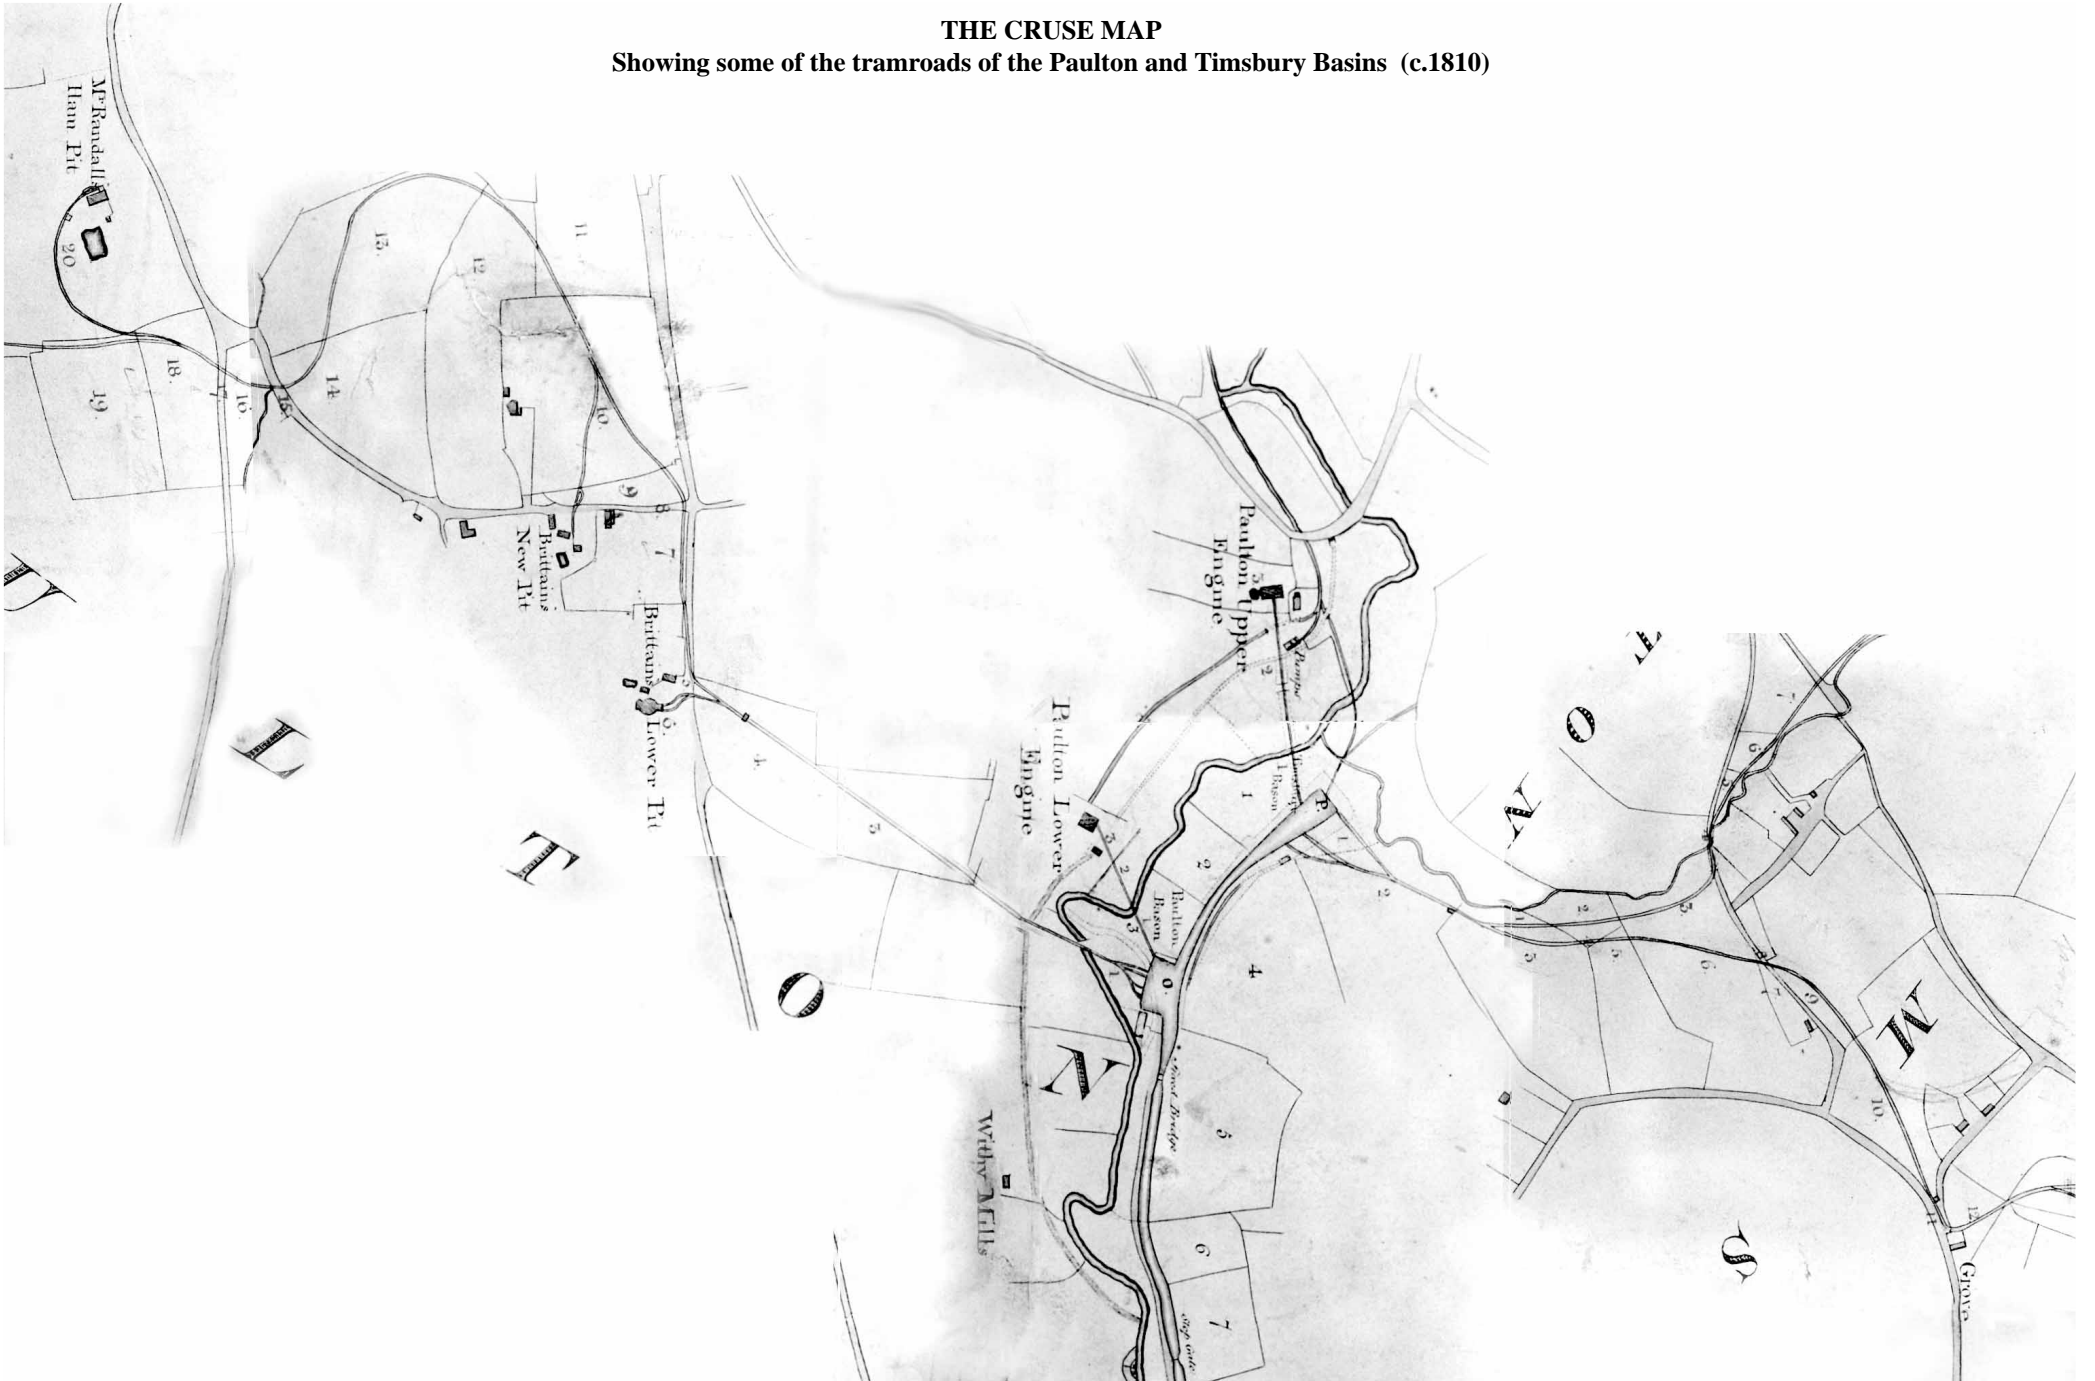
**THE CRUSE MAP**

**Showing some of the tramroads of the Paulton and Timsbury Basins (c.1810)**

To accompany the second part of Gilson and Quartley's article on the tramways of the Paulton Basin, I have devoted the centre pages of this issue to a section of the Cruse map which covers part of the area described. This will also be of particular interest to those members who were able to take part in our recent guided walk in this area.

† Also see Cruse map on Pages 11 - 12 of this issue
