WEIGH-HOUSE

THE MAGAZINE OF THE
SOMERSETSHIRE COAL CANAL SOCIETY

WEIGH - HOUSE N^o 70

Part 2 — Withy Mills to Terminus Bridge

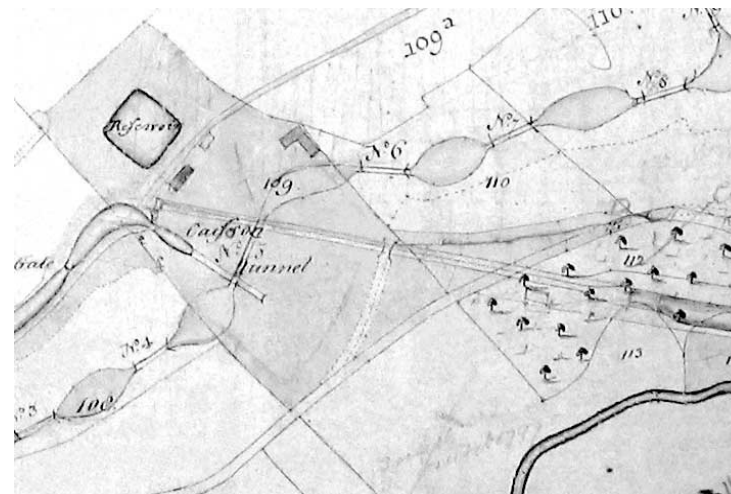
Fig.5 Detail taken from the draft map of the canal showing the state of affairs towards the completion of the lock flight at Combe Hay in 1805. The Caisson Lock has not yet been filled in, and the Inclined Plane is still in operation. Lower down, the road diversion and bridge over the incline is clearly shown, but the site of the Wharfinger's cottage at the lower basin is only sketched in.

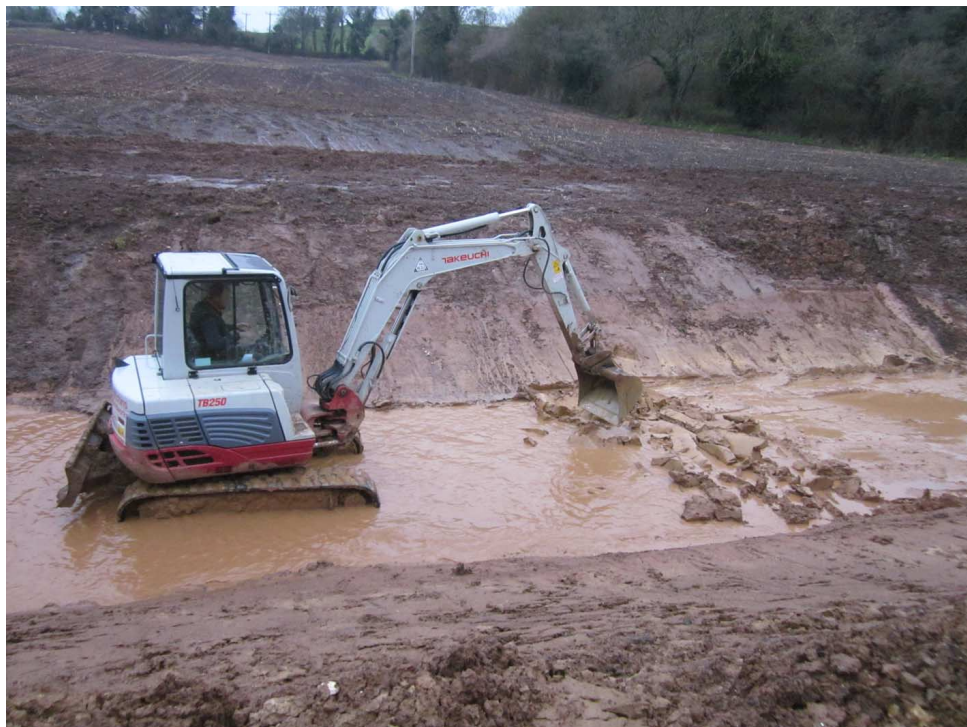
THE DIGGER PUDDLING THE CANAL BED

Because of the urgency to return the landowner's fields, the bed of the canal had been completely neglected. This now had to be made waterproof by puddling. Back in the Autumn, the digger driver had been somewhat sceptical when we asked him to chop up a short section of the canal bed clay, mix it with water and then roll it back in again with the digger's tracks - but he obliged us and made a good job of it. During the changes in weather which followed, that section of canal appeared to keep out the groundwater but retain rainfall, both good indicators that the clay had become properly waterproof. This technique was now used to waterproof the rest of the canal bed; it proving surprisingly quick and economical, with a skilled driver completing the remaining 250-metre length in a single day.

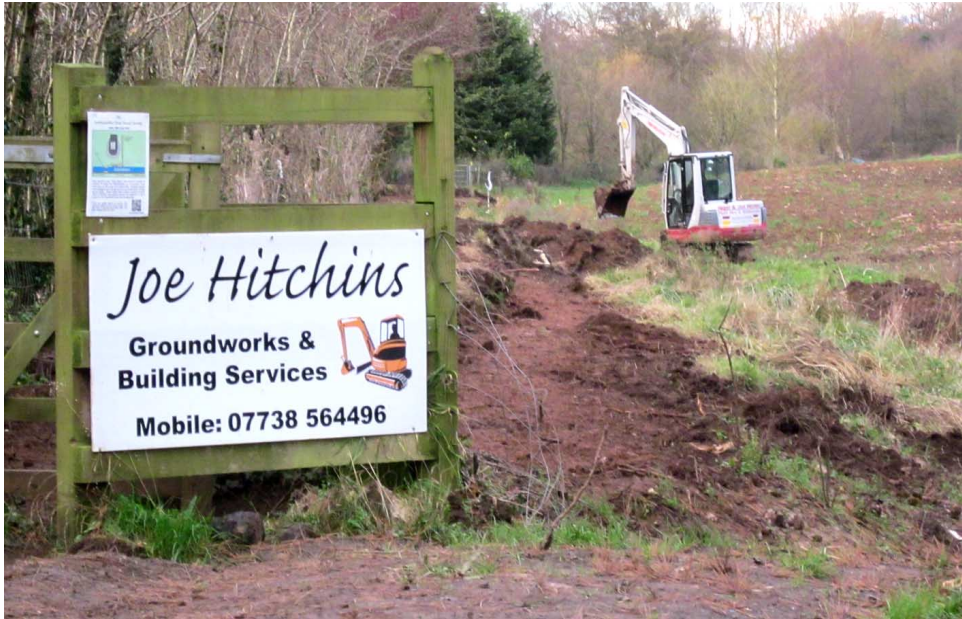
THE DIGGER BEGINS WORK ON THE TOWPATH WEST OF WITHY MILLS

It appeared that there had been a degree of subsidence in the towpath embankment, so the first task was to cut the topsoil away from half the width of the towpath and pile it on top of the remaining half, so as to raise its level to the height marked out by the nails. This exposed the top of the puddling clay, which we could then see was well below the required level. We had hoped to find sufficient natural clay in the offside bank to build the towpath-side puddle back up to the required level, but we soon realised that there was a mysterious lack of clay along some sections of the offside bank. Mike Chapman pointed out that his maps, from about 1825 onwards, showed that a winding hole had been dug in the offside bank to allow boats from Withy Mills colliery to turn without having to go all the way to Paulton Basin and back. The winding hole had later been filled in, but the infill, which now formed the offside bank, was permeable soil and quite unsuitable for making puddling. We presumed that the banks at the back of the winding hole had originally been made watertight, so there was no need for the infill itself to be impermeable.

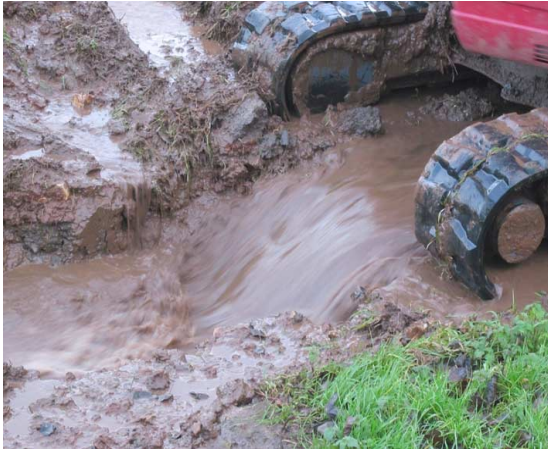
A DRAINAGE CHANNEL CUT BY THE DIGGER

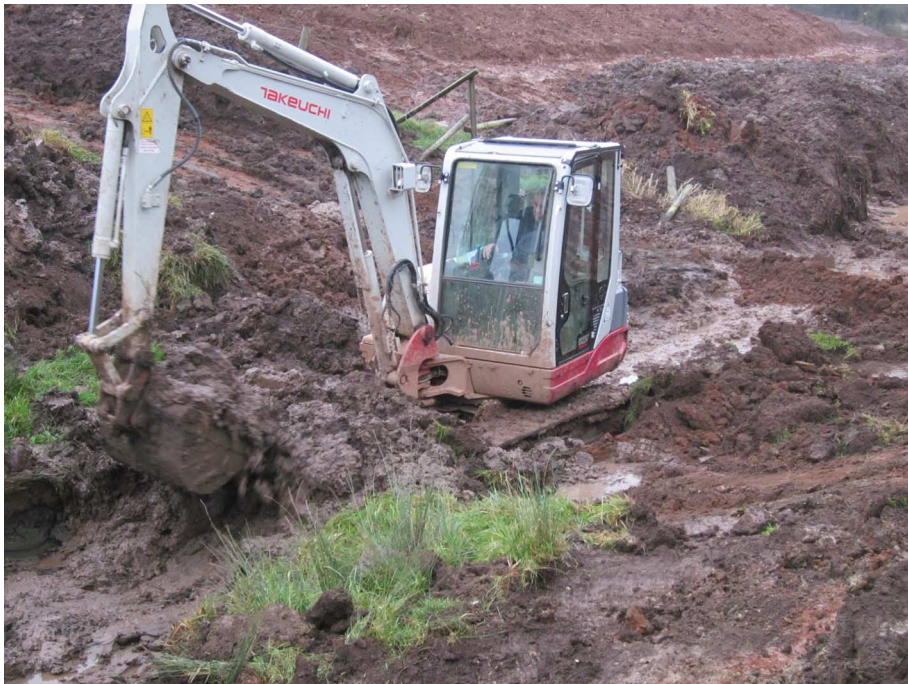
TIME TO GIVE UP — THE DIGGER COMPLETELY BOGGED DOWN IN MUD

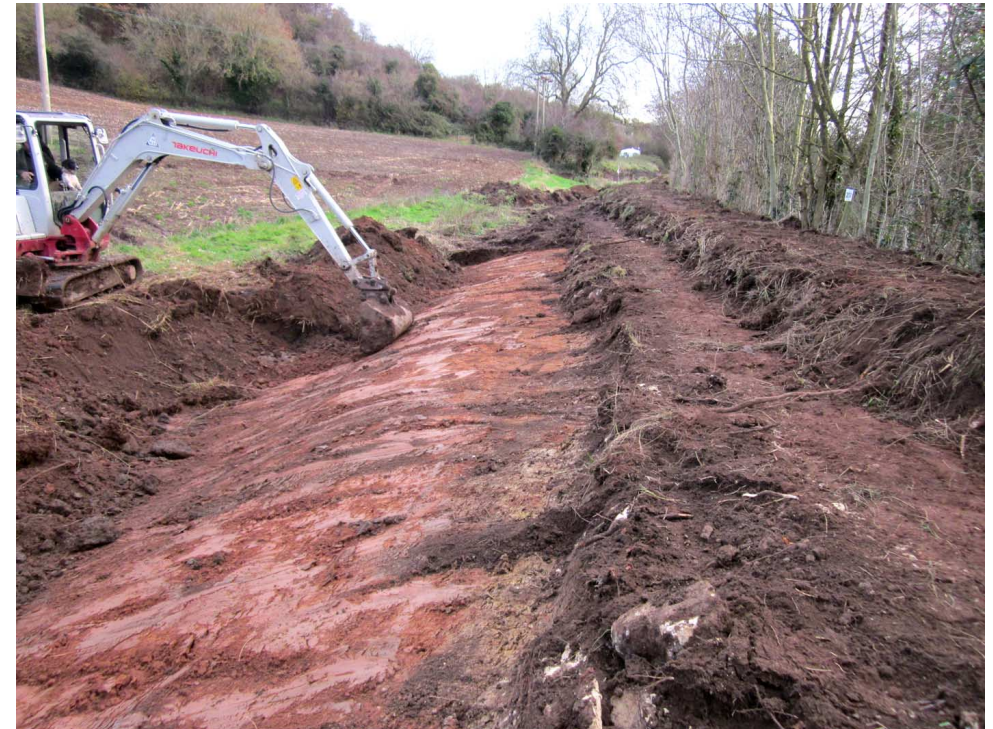
THE TOWPATH EMBANKMENT

Showing (left to right) the double slope, the rough stone wall and the newly-raised towpath.

In several places, the towpath embankment appeared to have a double slope, shallower at the top and steeper at the bottom. No explanation for this has been found in the literature, but it is possible that the shallower slope was tipped material which was not as compact as the untouched ground beneath it and had a greater tendency to slip if piled too steeply. The cross-section on p. 8 shows that the boundary between the original and the tipped material would be part way down the towpath embankment. →

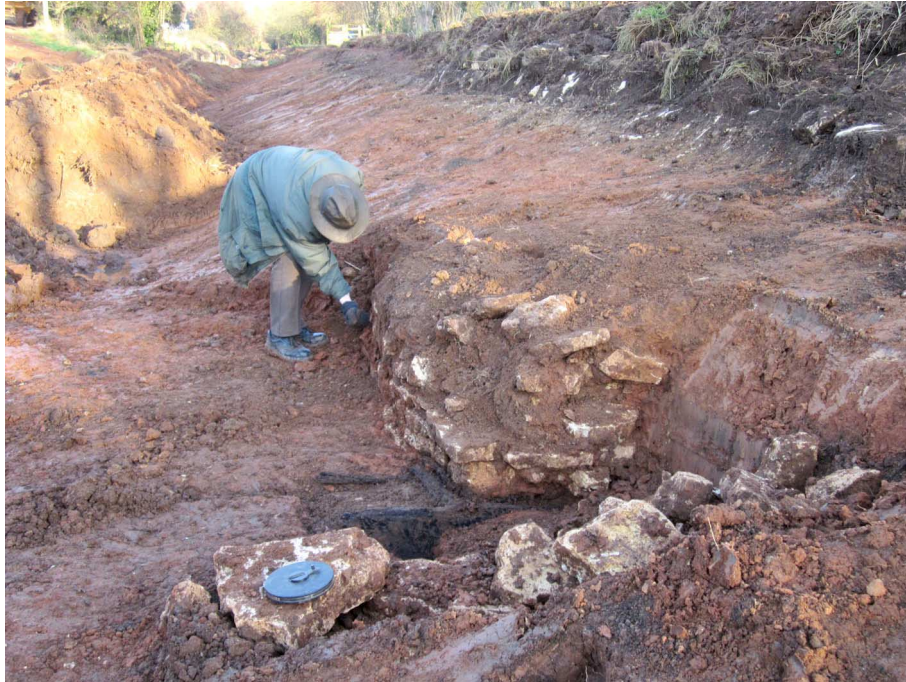
Above: MIKE CHAPMAN INVESTIGATING THE ROUGH STONE WALL WITH THE UNIDENTIFIED WOODEN OBJECT PROTRUDING FROM IT IN THE FOREGROUND
(Some of the stones have been removed from the wall to investigate how far the object extends back under the embankment.)

In the course of the digging, a wooden structure came to light at the foot of the embankment. It appeared to comprise two baulks of timber about 18” apart, they were about 2” wide and 18” deep and set at right angles to the embankment, with a short length projecting into the canal bed and an unknown length buried under the embankment. The tops of these two timbers had been joined by smaller planks nailed onto them. The space between them was plugged with a different type of clay from the surrounding pudding. We speculated that these could have formed a temporary drainage channel for use during repairs on that section, which was later blocked with clay when it was no longer needed. However, there is no sign of any sort of channel or culvert in the outer embankment wall, or in the meadow below.

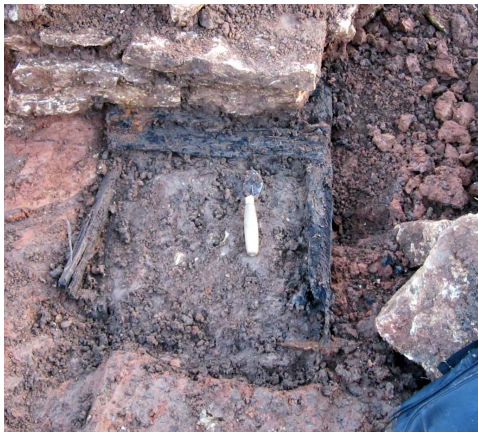
Left: A CLOSER VIEW OF THE OBJECT WITH AN ARCHÆOLOGIST'S TROWEL FOR SCALE
(Note the darker colour of the filling material.)

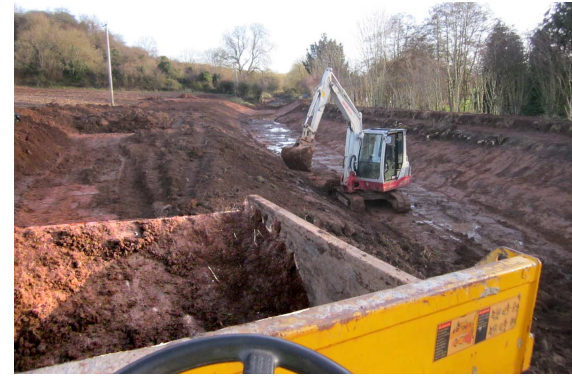
A VIEW OF THE DIGGER FROM THE SEAT OF THE DUMPER — The digger is lifting spoil up the embankment and the topsoil is piled to the left of the picture
