WEIGH-HOUSE

THE MAGAZINE OF THE
SOMERSETSHIRE COAL CANAL SOCIETY

THE LEAK AT WITHY MILLS

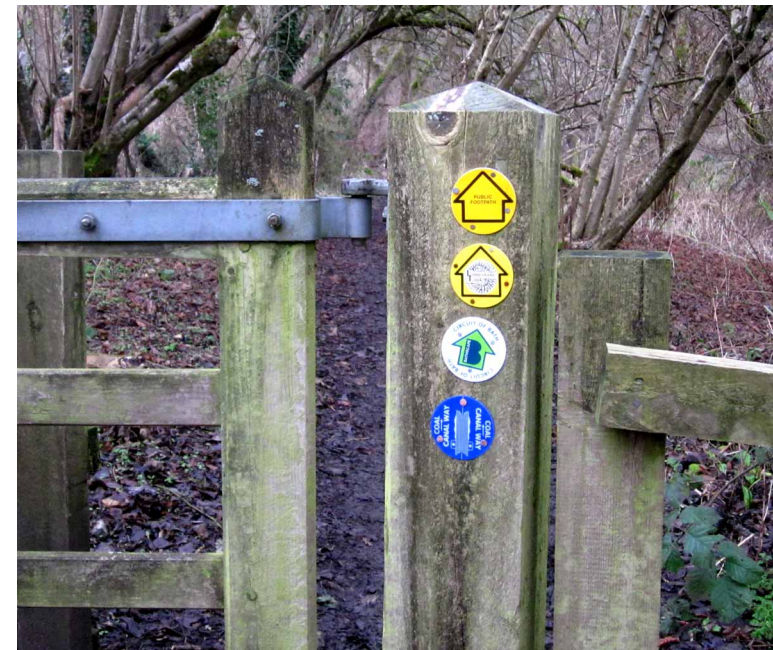
WAYMARKS AT A KISSING GATE

From top to bottom: Public Footpath; Limestone Link; Circuit of Bath; The Coal Canal Way.

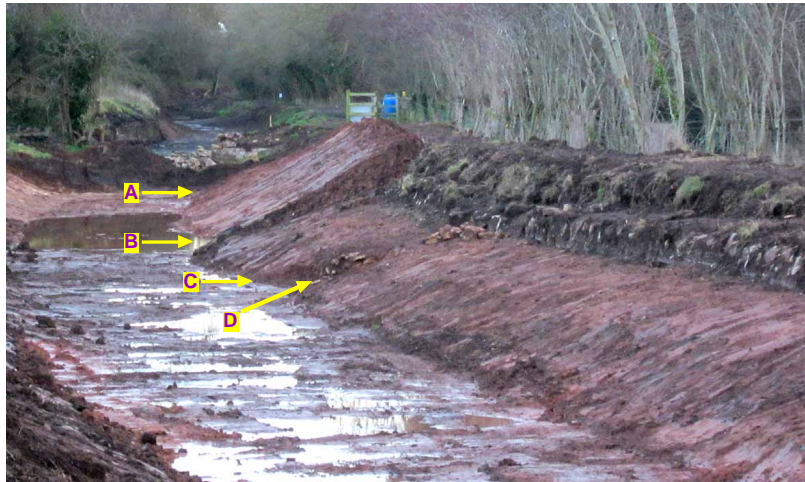
Fig 1 — EMBANKMENT PUDDLING UNDER CONSTRUCTION AT WITHY MILLS — December 2014

The repairs began at Withy Mills Stop Point (A) and had progressed as far as (B) when this photograph was taken on 10th December 2014. The layer of puddling on the embankment was about 18" thick, as recommended by most authorities on canal construction. There was no difficulty maintaining this thickness because a plentiful supply of natural clay could be dug out of the uphill bank, where it was easily within reach of the digger.

The first clue as to what might have happened was to be found in photographs taken at the time of the repair works. The work began at Withy Mills Stop Point and worked westwards. The photograph below [Fig 1] shows the situation after the first 75 metres had been completed.

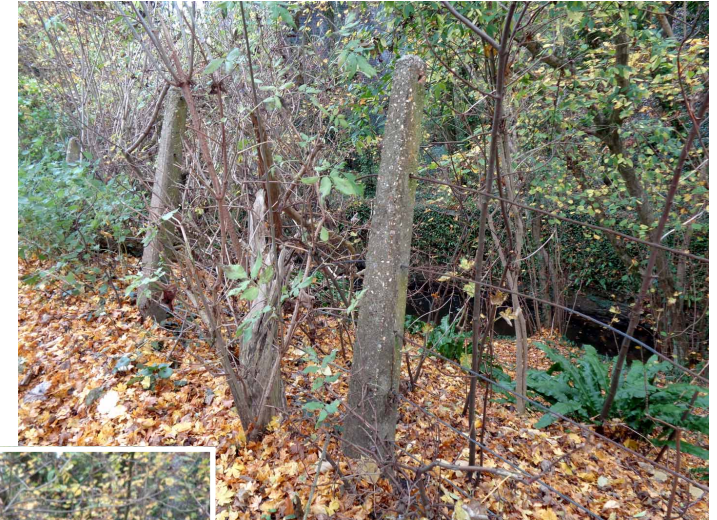
Fig. 1 — L.&S.W.R. FENCE POSTS AT TWINHOE LANE, MIDFORD

The concrete fence posts here are products of the London & South Western Railway's own Exmouth Junction Concrete Works (actually located on the outskirts of Exeter). The large proportion of pebbles visible differentiates them from the later, Southern Railway version, which had fewer pebbles in the mix, and thus a much smoother surface.

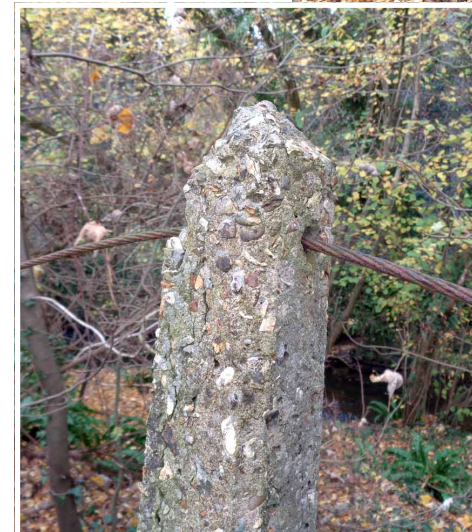
Fig. 2 — CLOSE-UP VIEW OF POST AND WIRE

If you look closely you will see that the fence wires are threaded through holes in the posts. This was found to be a nuisance if a wire had to be replaced, as the remains had to be withdrawn and the replacement wire laboriously threaded through all the holes. Because of this, any new fence posts which were being installed were positioned with the holes at right angles to the line of the fence, with the wires fixed along the outer face and secured with split pins through the holes. This made replacing a wire much easier.

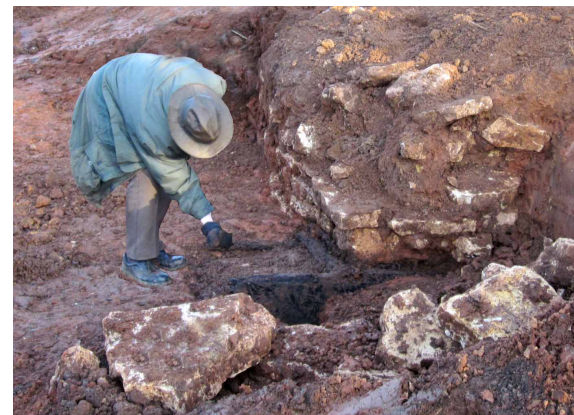
Fig 2 — MIKE CHAPMAN EXAMINING THE ‘THING’
The stone wall at the base of the embankment has been partly dug away and a small pit has been excavated along the side of the wooden object to try to assess its overall size.

At (D) we discovered a curious ‘thing’ whose purpose we could not imagine [See Fig 2]. It appeared to be a wooden trough with a slatted lid, set into the base of the embankment and forming a

rectangular duct underneath it. It was packed solidly with waterproof clay of a distinctly different appearance from the clay in the embankment surrounding it. We got the digger to remove some of the embankment so that we could follow along it, but its purpose did not become apparent at the time and has only been guessed at quite recently.

This excavation also confirmed that the base of the embankment incorporated a stone wall, which was a most unusual feature for canals before the 1880s, although it was used at that time in the construction of reservoir dams. It was more expensive than standard canal constructions and tended to be reserved for sections that were particularly at risk and needed more strength than usual.

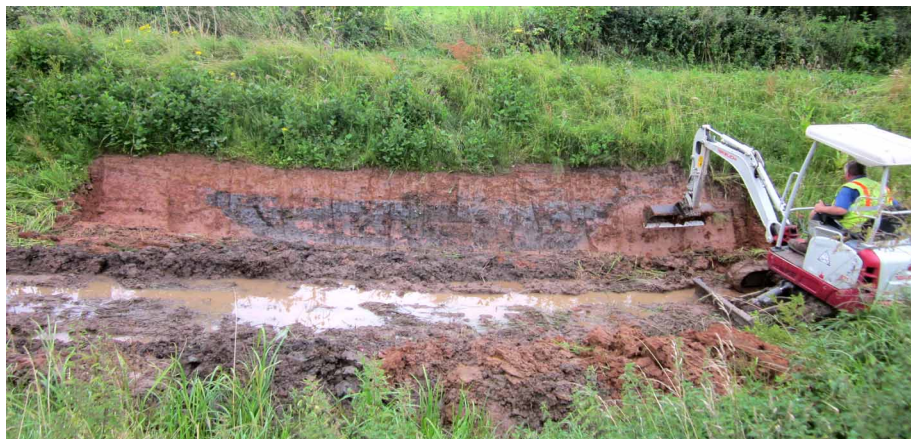
Fig 4 — CANAL EMBANKMENT SHOWING PATTERN OF COAL WASTE INFILL

The shape of the infill showed that there had been a major washout through the canal embankment at the point where it was closest to the brook. It had been patched up with materials which were easily to hand, such as local soil and coal waste. As those materials were porous, they had been waterproofed on the canal side by a layer of puddling clay and it was this layer of clay which we had thinned down

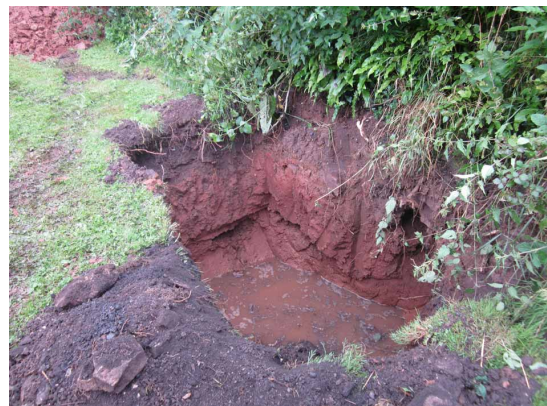
Fig 5 — THE LEAKS COMBINING IN PASSAGeways ON THE DOWNHILL SIDE OF THE CANAL EMBANKMENT

when repairing the canal in 2014. The boundary between the puddle clay and the porous infill was not a perfectly flat plain, so at the places where the infill poked through the puddling, a leak would develop. Repairs to this leak would raise the water table and then other leaks, with just a thin layer of protection, would start to seep and eventually wash through into big holes. This accounted for the whole line of leaks which kept appearing all the way along the washed-out section and combined underground into two major outlets that jetted plumes of turbidity into the Cam Brook.

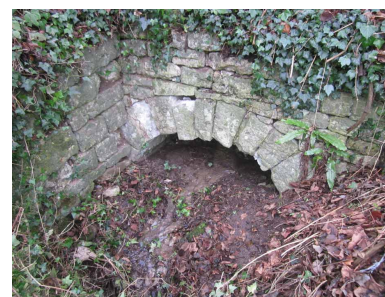
Fig 3 — THE SLUICE

This structure is located underneath the towpath and easily missed unless you spot the stream which still runs through it [see Fig. 3]. This stream runs into the field below and disappears into the ground, which might suggest there is an underground stone culvert between here and the brook.

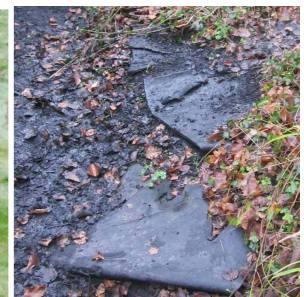
Fig 5 — THE INFILL

The canal just South of Tucking Mill has been filled in. No walk would ever be complete without discussing the contents of the infill and the potential problems in restoration. There is a large quantity of decomposing sheet rubber in the infill [See Fig. 5], which would be difficult and expensive to remove from the site. The footpath runs along the foot of the embankment at this point, but if it were reinstated along the towpath, the canal infill could easily be dug out and tipped at the embankment base, where the extra weight would help stabilise it.

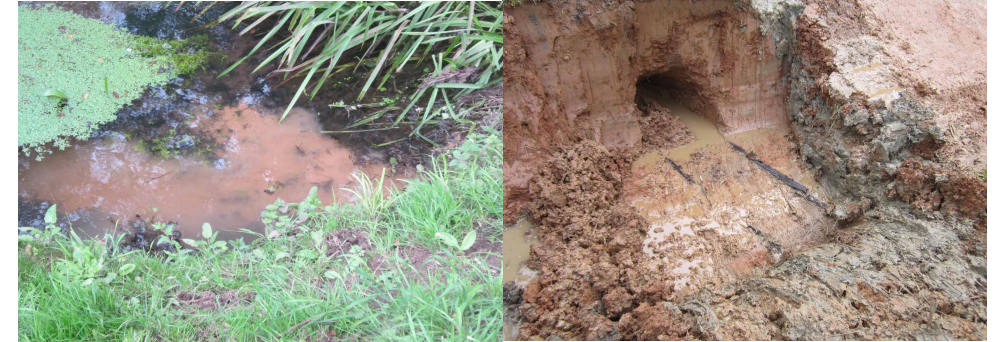
Fig 6 — THE PLUME OF TURBIDITY AND THE 'THING' WHICH WAS THE SOURCE OF IT

By directing the water to different places in the canal, it became apparent that the leak for this plume was in the neighbourhood of the 'thing'. The top slats had been removed from the 'thing' and further excavation revealed that it had once been a wooden sluice.

It was probably built as a temporary drain to keep the work site dry while repairs were being effected on the embankment; its level, just slightly below the canal bed, would have been appropriate for this. When the work was completed, it had been blocked off with a thick plug of any type of clay which was to hand, there being no need to match it to the existing puddle clay.

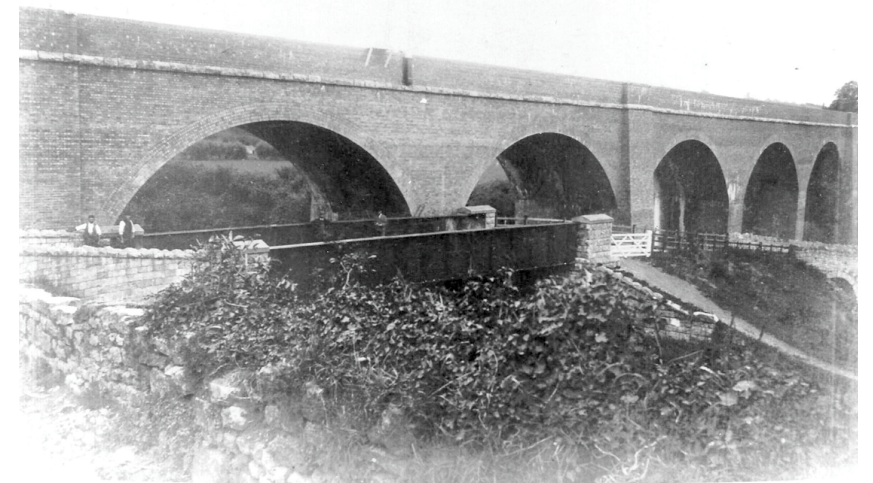
Photograph: S&DRT
Fig. 14 — S&D RAILWAY VIADUCT & TWINHOE LANE BRIDGE c.1895
The 'New' Road Bridge over the canal.

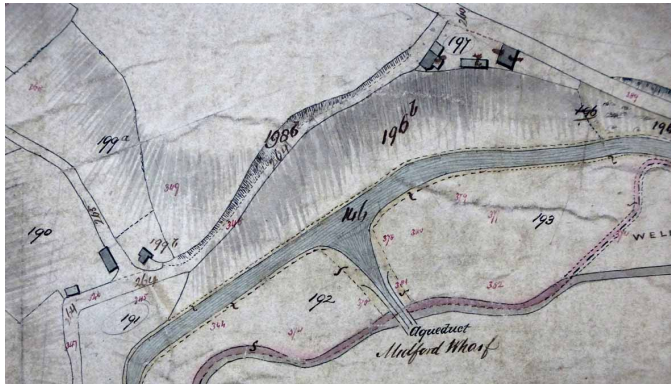
(Left)
**Fig. 11 SOUTH STOKE TITHE
MAP c.1840**

Midford Accommodation Bridge is far more important than some would think. It once carried the main packhorse road between Midford and Twinhoe over the canal. The former packhorse road (marked as N^o 1986 on the map) comes down the hill from the main Bath Road, skirts around the orchard (Field N^o 191), over the canal bridge, and heads towards the Cam Brook. It would have crossed the Cam Brook *via* a ford and run along the back of the canal/tramway interchange basin (wharf), crossing the route of tramway, before turning south towards Twinhoe. Part of the road between the bridge and the ford can still be traced today as there are still some remains of the stone walls that were each side of the road.

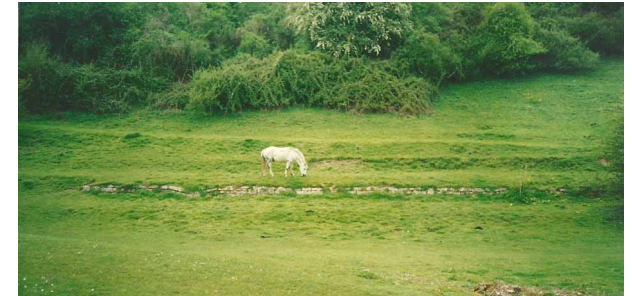
Fig. 8 — MIDFORD 1998 — Showing the stone wall at the base of the northern towpath

Continuing from p.19 of WH 82, Roger's walk has taken us as far as Midford Aqueduct, opposite which is a stone wall protecting the northern towpath from boats leaving the aqueduct.

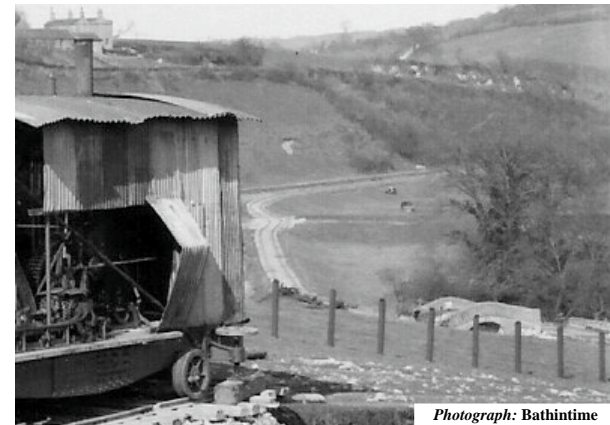
Fig. 9 — 'MAKING NEW RLY.' c1909
The temporary contractor's railway running along the former canal towpath towards the camera; past the entrance for the Midford Aqueduct (shown as a slight kink in the line) and towards the Midford Accommodation Bridge.

In 1904 the canal was acquired by the GWR, who between 1907-1910 built the new branch line from Camerton to Limpley Stoke. The railway closely followed the line of the former canal. During the railway's construction the southern towpath came back into use, this time transporting materials for the railway. Here the railway contractor used the former towpath as the base for a temporary railway between Midford and Combe Hay. [See WH 76, 77, 78 and 80 for further details on the Contractor's Railway] Approaching the Midford Accommodation Bridge, the horse would now cross over the bridge to re-join the southern towpath.
