The Somersetshire Coal Canal

Restoration Plan - Baseline Assessment

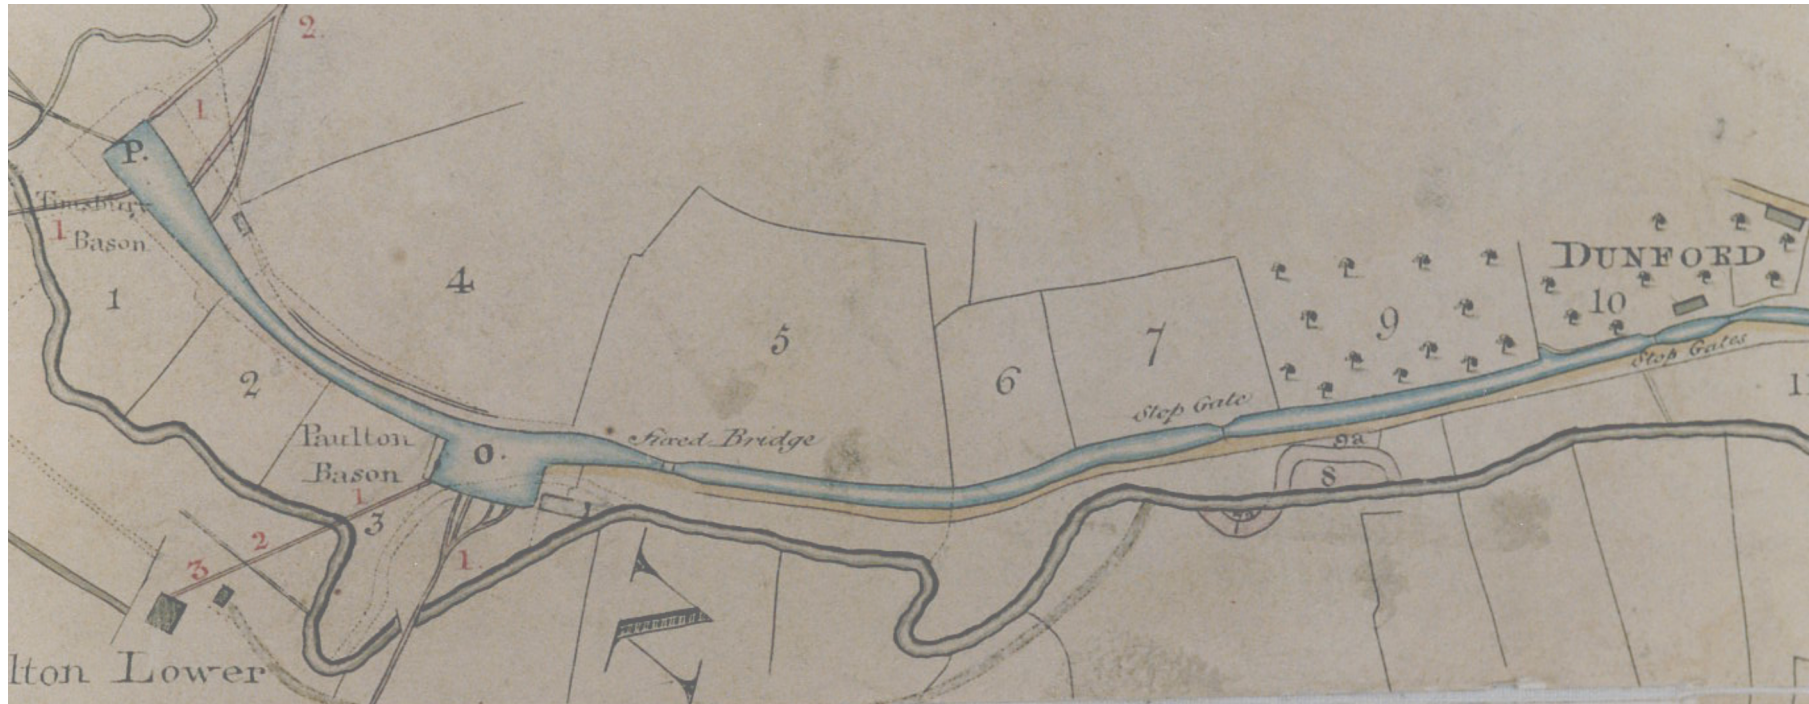
Map pages

Timsbury Basin to Radford	5	Combe Hay to Combe Hay Lock Flight	11
Radford to Camerton	6	Combe Hay Lock Flight to Midford	12
Camerton to Withyditch	7	Midford	13
Withyditch	8	Midford to Tucking Mill	14
Withyditch to Dunkerton	9	Tucking Mill to Monkton Combe	15
Dunkerton to Combe Hay	10	Monkton Combe to Dundas Wharf	16

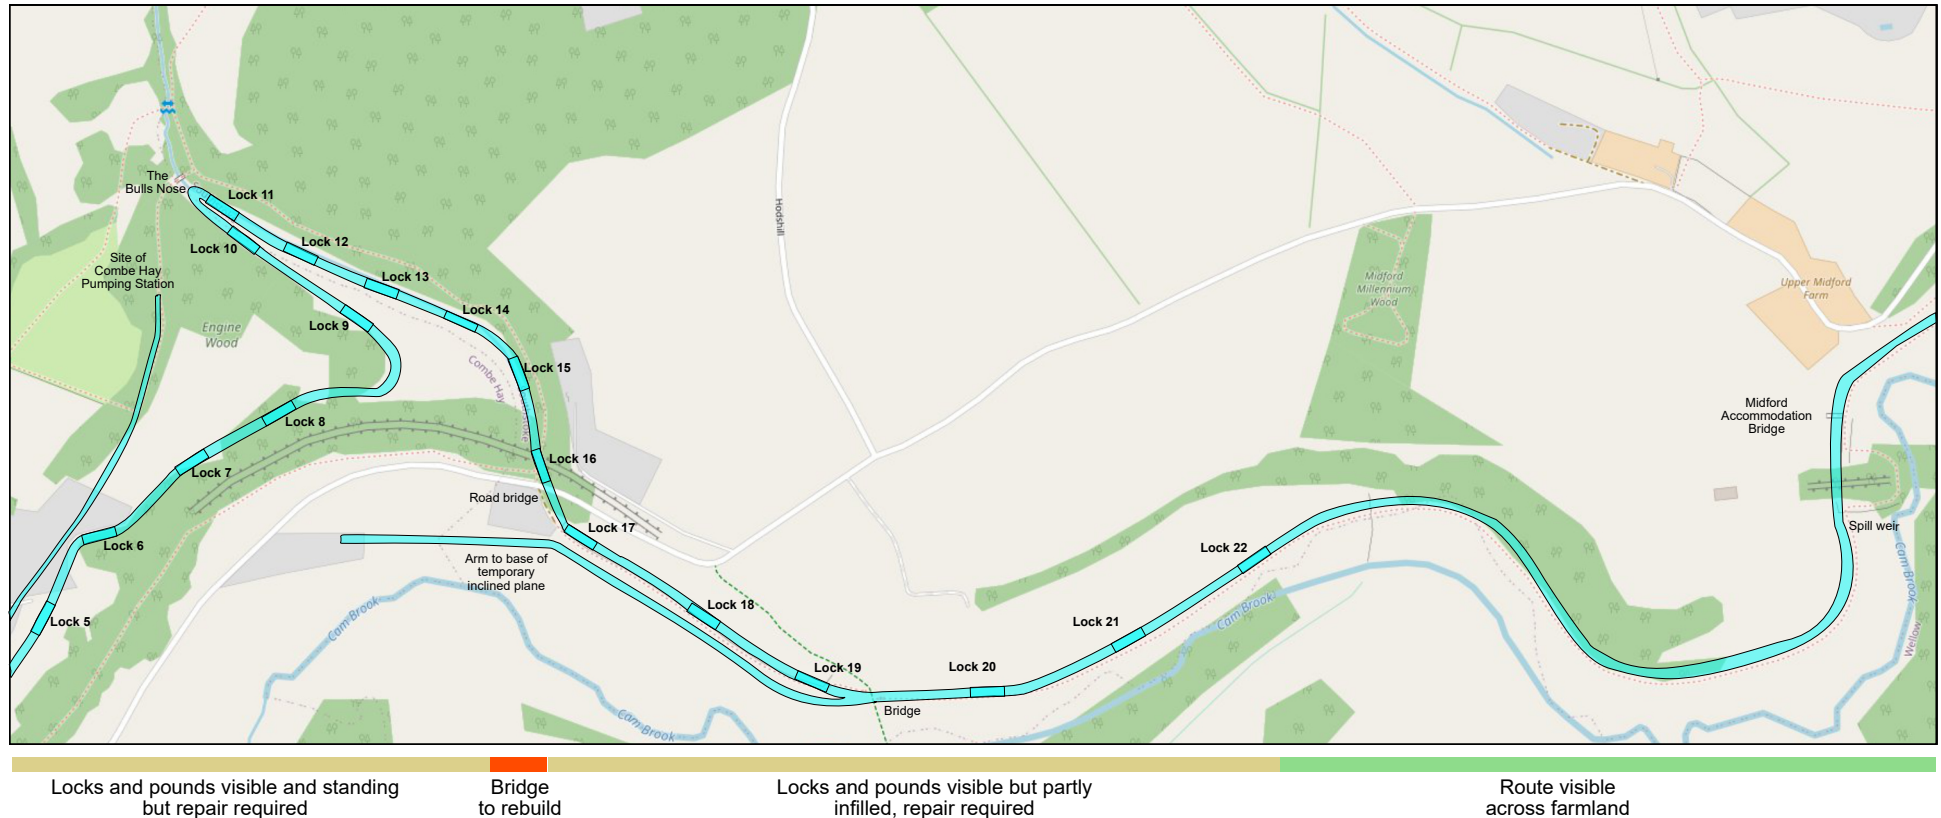
Combe Hay Lock Flight to Midford

This section contains the majority of the Combe Hay Lock Flight. The locks and pounds from lock 1 to 10 and locks 12 to 15 are generally in good condition although the stonework has suffered from some frost damage and so sections of the walls will need to be repaired. The lock gates and ironwork are generally missing and the pounds are partially silted up.

The walls of lock 11 have collapsed and an embankment was built across lock 16 during the construction of the GWR railway. Locks 17 to 22 have been fully or partially infilled but their remains are, in part, still visible.

The canal arm that ran from below lock 19 to the base of the inclined plane is still visible. The remains of the terminus basin at this point are in good condition, although partly silted up. This arm was also used to provide water to the lower locks from a weir on the Cam Brook. The Combe Hay Pumping Station was supplied with water, via culvert, from here to feed the upper section of the canal. The detailed restoration design will need to address the water supply requirements of the upper canal reaches,

The canal continues, and is clearly visible, across farmland until it is crossed by another large embankment built during the construction of the GWR railway. Nearby is the remains of a spill weir that returned water to the Cam Brook by culvert. On the other side of the embankment the canal is visible and continues across farmland. It is crossed by Midford Accommodation 'pack horse' bridge, which is still intact but is in need of repair.

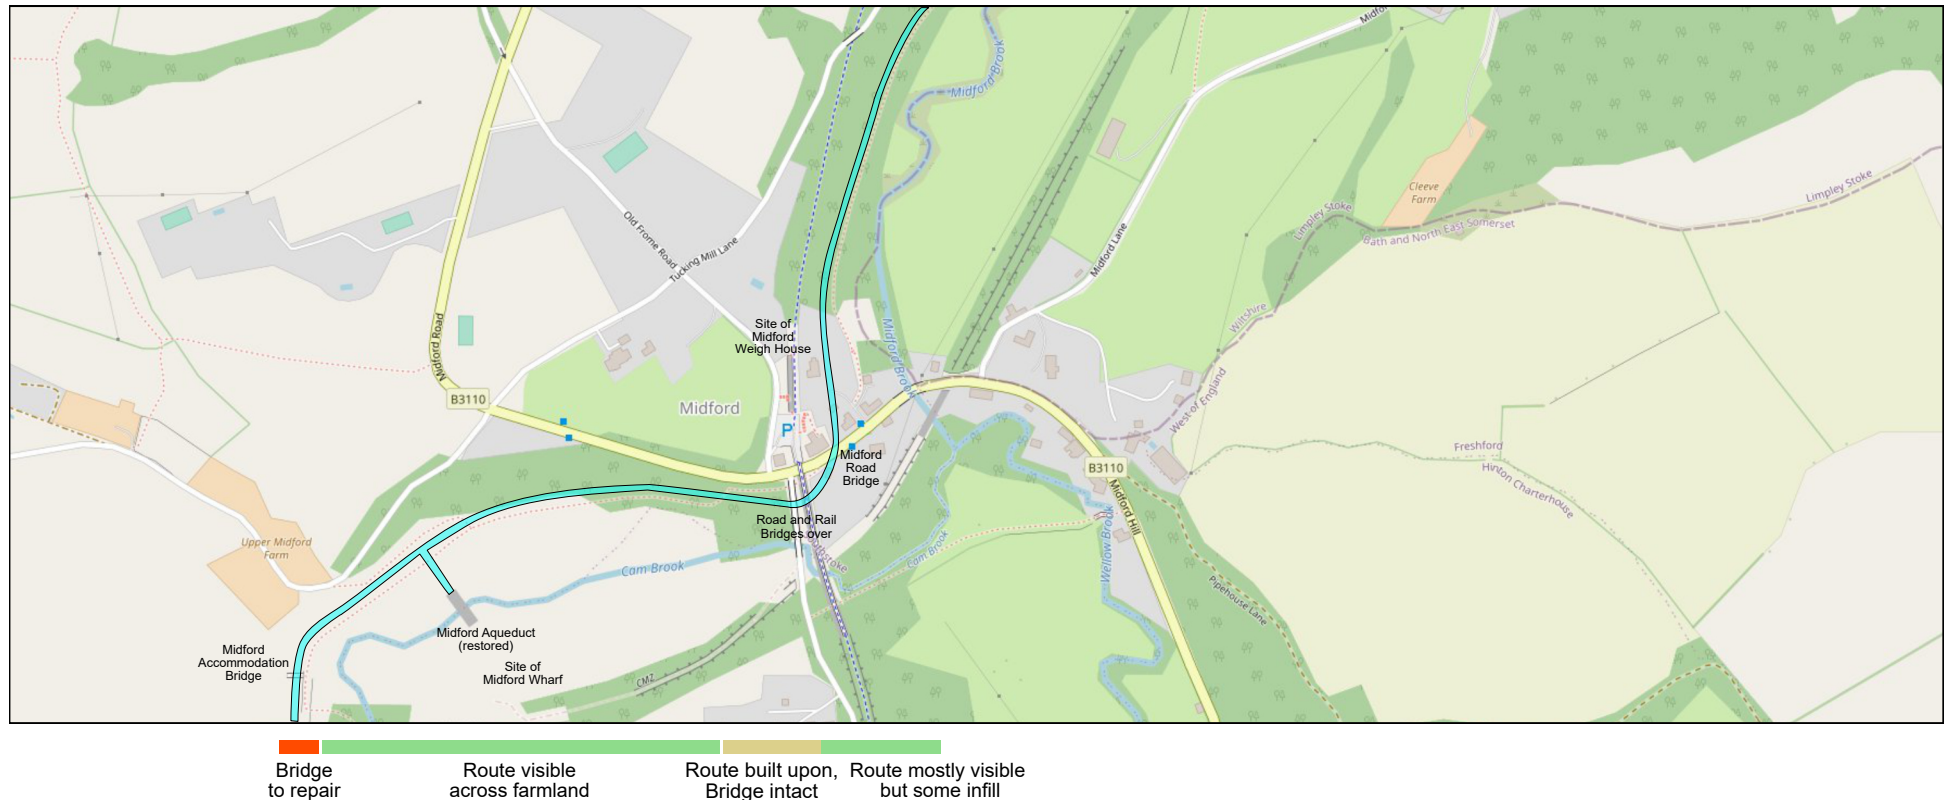
The route of the canal continues to the east of Midford Accommodation Bridge and is clearly visible across farm land. A short spur leads to the south and crosses the restored Midford Aqueduct. There was a transshipment basin to the south of the aqueduct which has been infilled in the distant past.

Two metal sewer pipelines cross the canal in this section, supported on piers.

The canal route passes under a steel road bridge and the arches of the Midford Viaduct of the Somerset and Dorset railway (now a cycle path). The route at this point passes through private gardens to the intact Midford Road Bridge beneath the busy B3110.

The SCC Weigh House would have been found immediately to the north of the road bridge. The weighing station has been demolished and the adjoining dwelling extended into a family home.

Continuing northwards the canal is clearly visible but has suffered from partial infill by stone and spoil that has slipped down the steep valley sides from the course of the Somerset and Dorset railway above.
